Site Electrical Installation Verification Log Book

Site / Location: -	CE3815, Heleba Bank, 3, Noble St, London, EC2V 7DE		
Project Manager: -	R M	Visit Date : -	09/11/2021
Site Operative:-	S G	Due Date: -	17/11/2021
		Certificate	Draft 90%
Visit Limitations:-	2nd fix, ceilings & walls closed	Status:-	complete

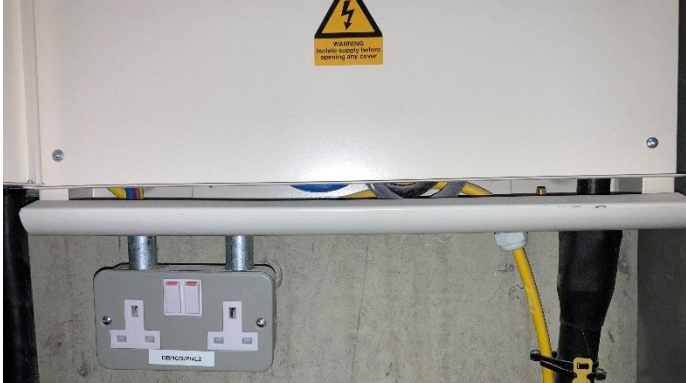
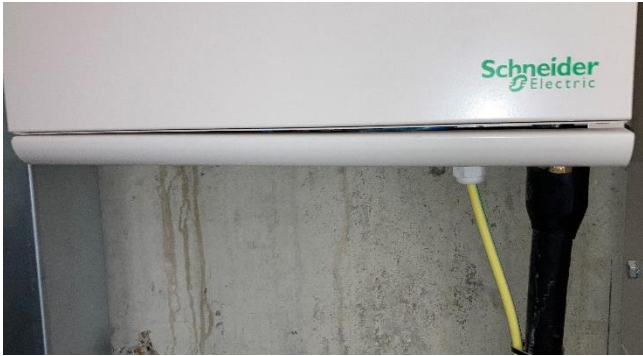
ITEM	Complete
<p>1. The Existing SWA cables feeding the existing DB's 10-2-P & 10-2-L in riser 2 have caused the enclosures to become bent out of shape. Reroute the cable or relocate the DB so there is no mechanical strain on the cable, gland or termination & return the enclosure to IP4X before handover as required by BS7671 2018. (Sections 416, 522.6 & 522.8). Or record in comments on existing.</p> <div style="display: flex; justify-content: space-around;">

</div>	<p>No</p>

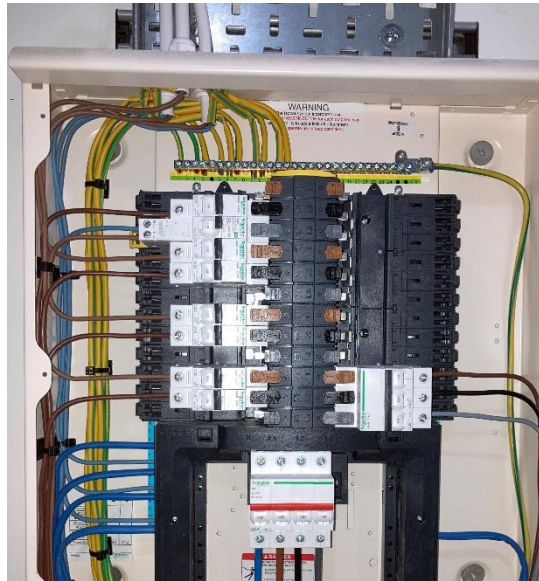
2. The retained commando sockets in the comms room are not RCD protected & no risk assessment on the previous certificate. **Install suitable RCD protection to all socket outlets before handover in line with BS7671 2018 (411.3.3).**

If required a risk assessment could be used to remove the requirement for RCD protection to the comms Cab C-Form sockets.

RA sent to client

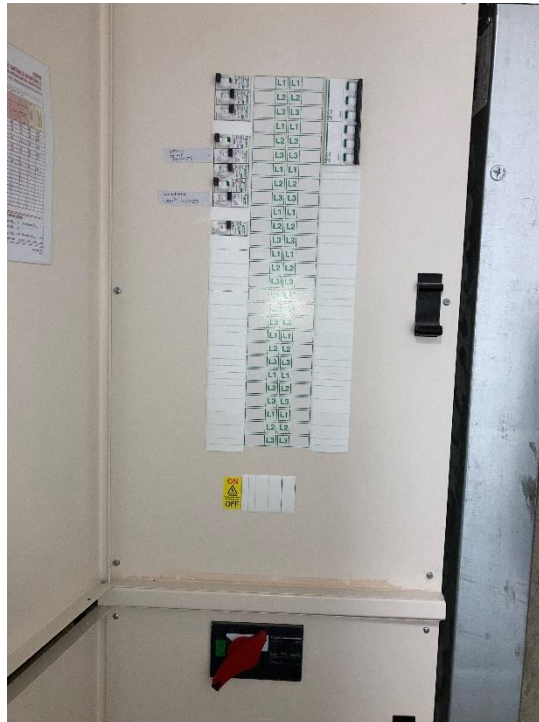
3. Surge Protection has not been fitted to existing reused DB's. **Fit surge protection before handover as required by BS7671 2018. (Section 534) unless the circuits have no vulnerable equipment, or it has been excluded in writing.**

No

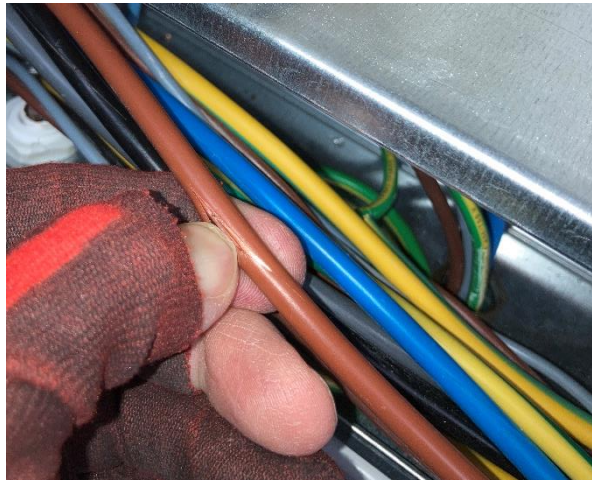
4. The retained comms DB supply cable has damaged insulation to the L1 core leaving access to exposed conductive parts. **Install suitable heat shrink insulation to prevent contact as required by BS7671. (section 416.2). Take more care when stripping cables.**

Part comp, heat shrink to finish

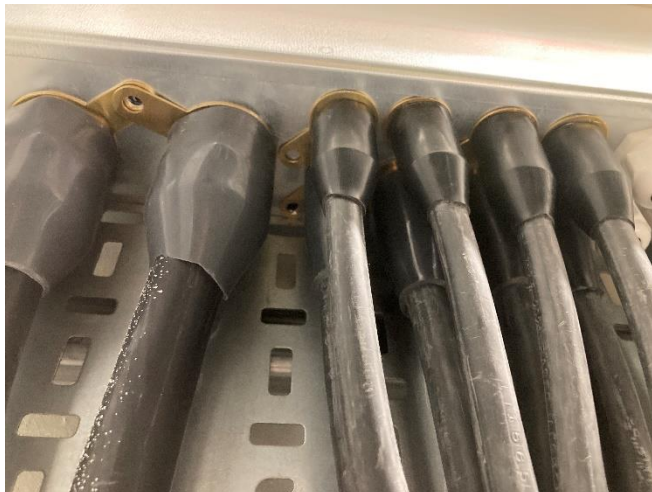
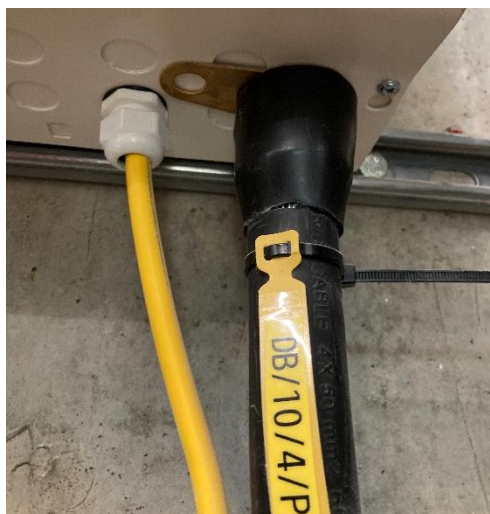
5. No bolts fitted to any of the existing reused SWA gland banjos in the comms room. No bolts fitted to the existing reused sub main SWA gland banjos feeding DB/10/4/P or DB/10/4/L **Ensure the SWA glands have bolts fitted to banjos before handover in line with BS7671 2018. (411.3.1.1) or record in comments on existing where circuits have not been altered.**

No

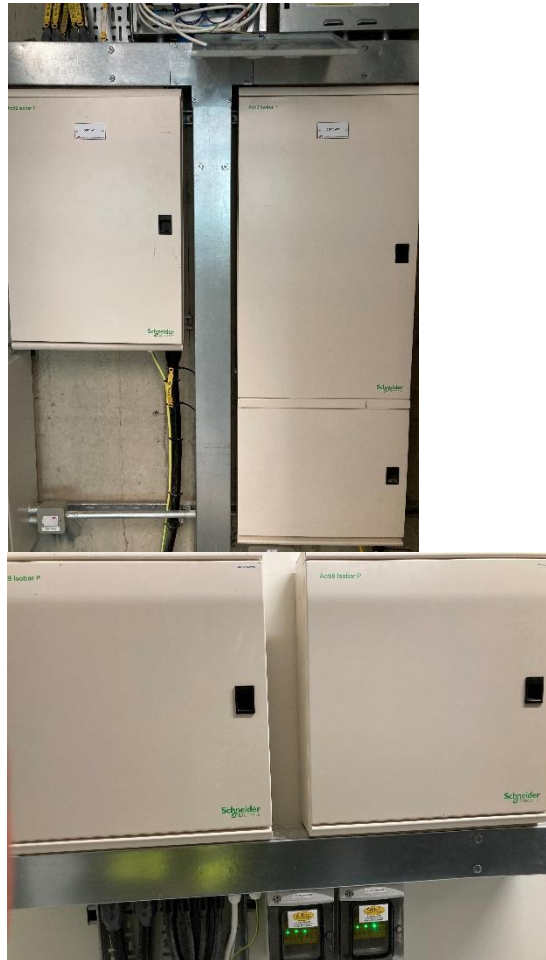
6. RCD test, next inspection labels to be fitted to DBs. Ditto updated DB charts fitted to DBs, Ditto downstream SPD or high protective conductor currents warning labels (if required). **Fit required labelling & DB schedules to ALL DB's in line with BS7671 2018 before handover. (534.4.1.7 for SPDs, 543.7.1 for protective currents & Section 514)**

No
